# ZENITH

## Repairs to Internal Steel Liner Support Steelwork within a Reinforced Concrete Chimney Windshield

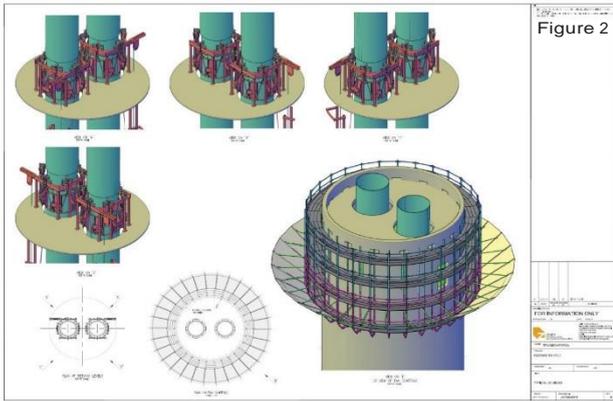
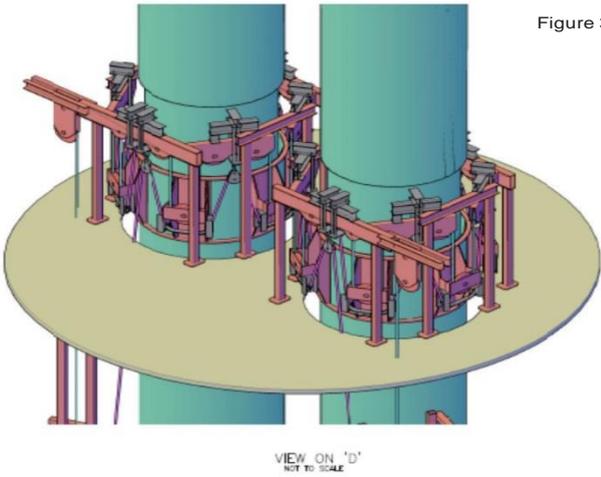
Internally there are 2 No steel chimney liners, one to the North and one to the South. These are accessed by a series of ladders and rest landings. The internal liners have expansion bellows and a support system which are supported on a wire rope and reeve system with counter balance weights (figures 2 & 3).

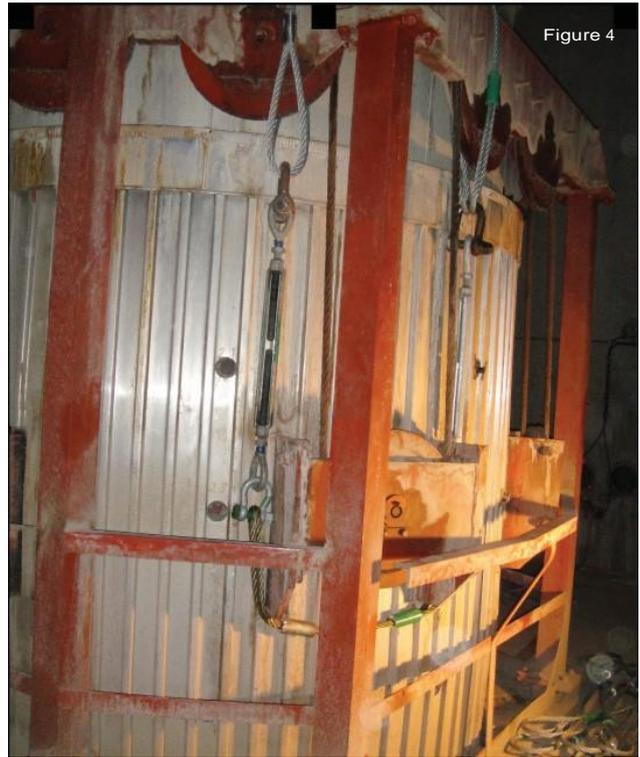
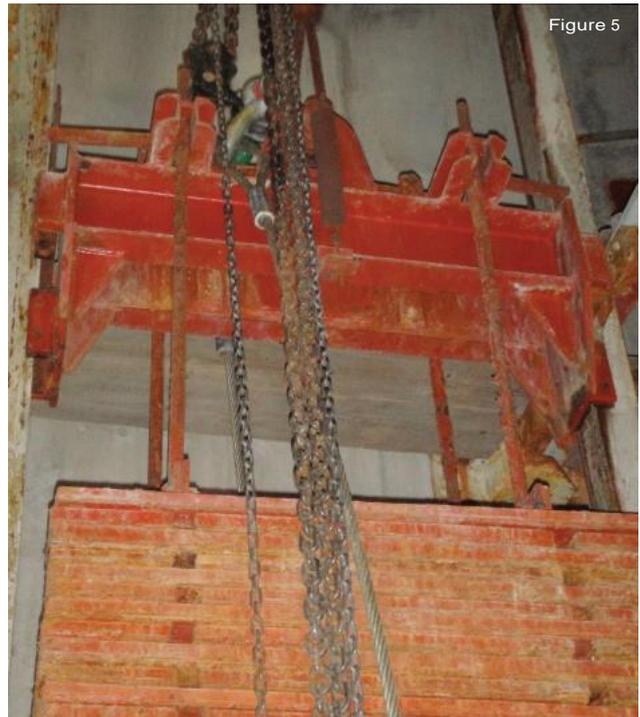
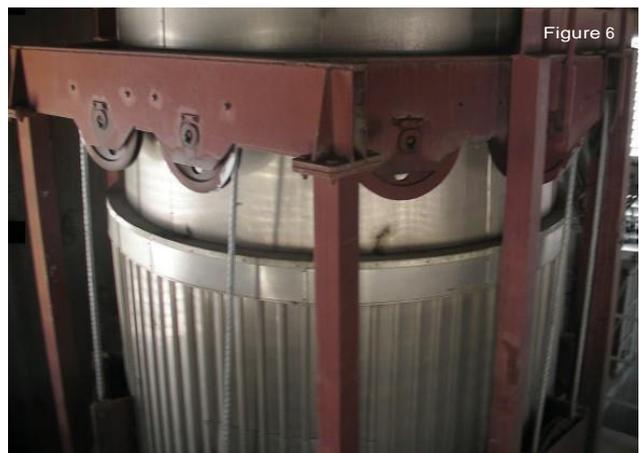
The wire rope counter balance mechanism (figures 4,5 and 6) was found to be in a state of disrepair and unserviceable. Extensive corrosion was noted throughout the mechanism particularly at the lower levels. The corrosion was at a state where the replacement of the ropes and the rope eyelet supports were deemed essential.

An aggressive atmosphere was noted within the annulus. The presence of a prevailing up draught was due to the large void width between the concrete windshield and the steel chimney liners. A large cross variation in temperature was recorded which had allowed the dew point to vary across the void resulting in condensation settling on the wire ropes.

The corrosion reduced with height as the void decreases in width, but light corrosion was found to be endemic. To avoid the need for maintenance in the near future it was proposed that the entire rope system within the chimney should be replaced. The up draught was being accelerated by the fact that the external gantry access doors were defective or were completely missing, creating external voids in the windshield. Alternatively if the upper levels of ropes were to have been retained, the swaged socket connections should be examined and replaced, if required, and all ropes and pulley systems should be thoroughly lubricated. It was recommended that all doors through the concrete windshield should be reinstalled or replaced with an adequate locking system. This was deemed essential to reduce the up draught thereby causing the corrosion in the wire ropes.

Due to the lack of maintenance, it was proposed that protection of the wire could reduce the effect of environmental attack and extend the life of the ropes. This lack of maintenance, with no protection, has contributed to corrosion acceleration.

The wires to the balance system were failing and required changing out with an additional system installed to reduce single point of failure.
