# ZENITH

## Repairs to Internal Steel Liner Support Steelwork within a Reinforced Concrete Chimney Windshield

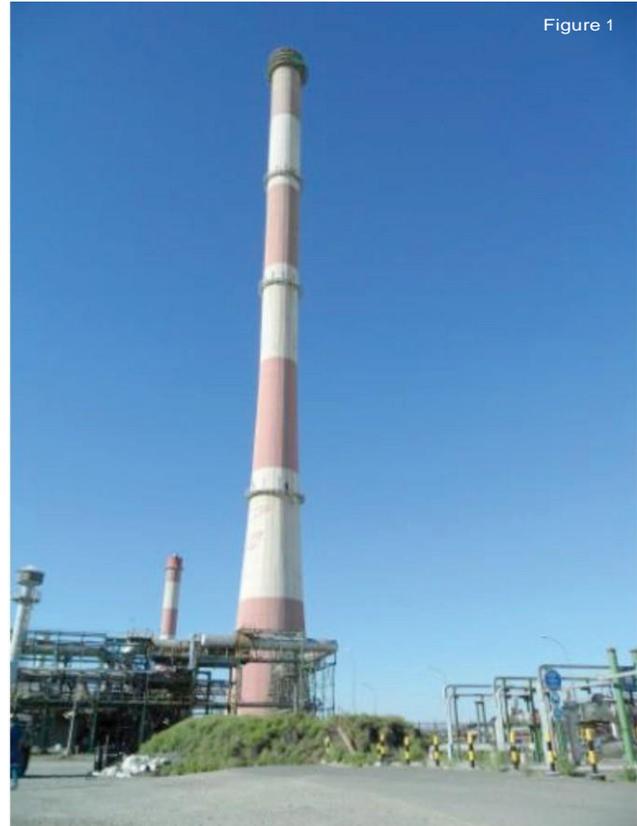
Figure 1

This particular structure (figure 1) was constructed and commissioned in 1984 and has suffered from the absence of a proactive inspection and maintenance plan. In recent years the asset management and the local authorities have actively pursued a shift in attitude from reactive to proactive maintenance. Zenith was engaged to provide inspection criteria to determine a 'benchmark' condition in order to engage future inspection and maintenance.
